## Abstract

The aim of this post-tsunami survey was to acquire ground truth data on tsunami run-up and horizontal inundations and to correlate them with coastal bathymetry and geo-morphology. The correlation of ground truth data with coastal bathymetry and morphology provided a broader view of the behaviour of tsunami wave propagation. Coastal bathymetry and geomorphology are the major factors that determine the influence and severity of the tsunami waves.

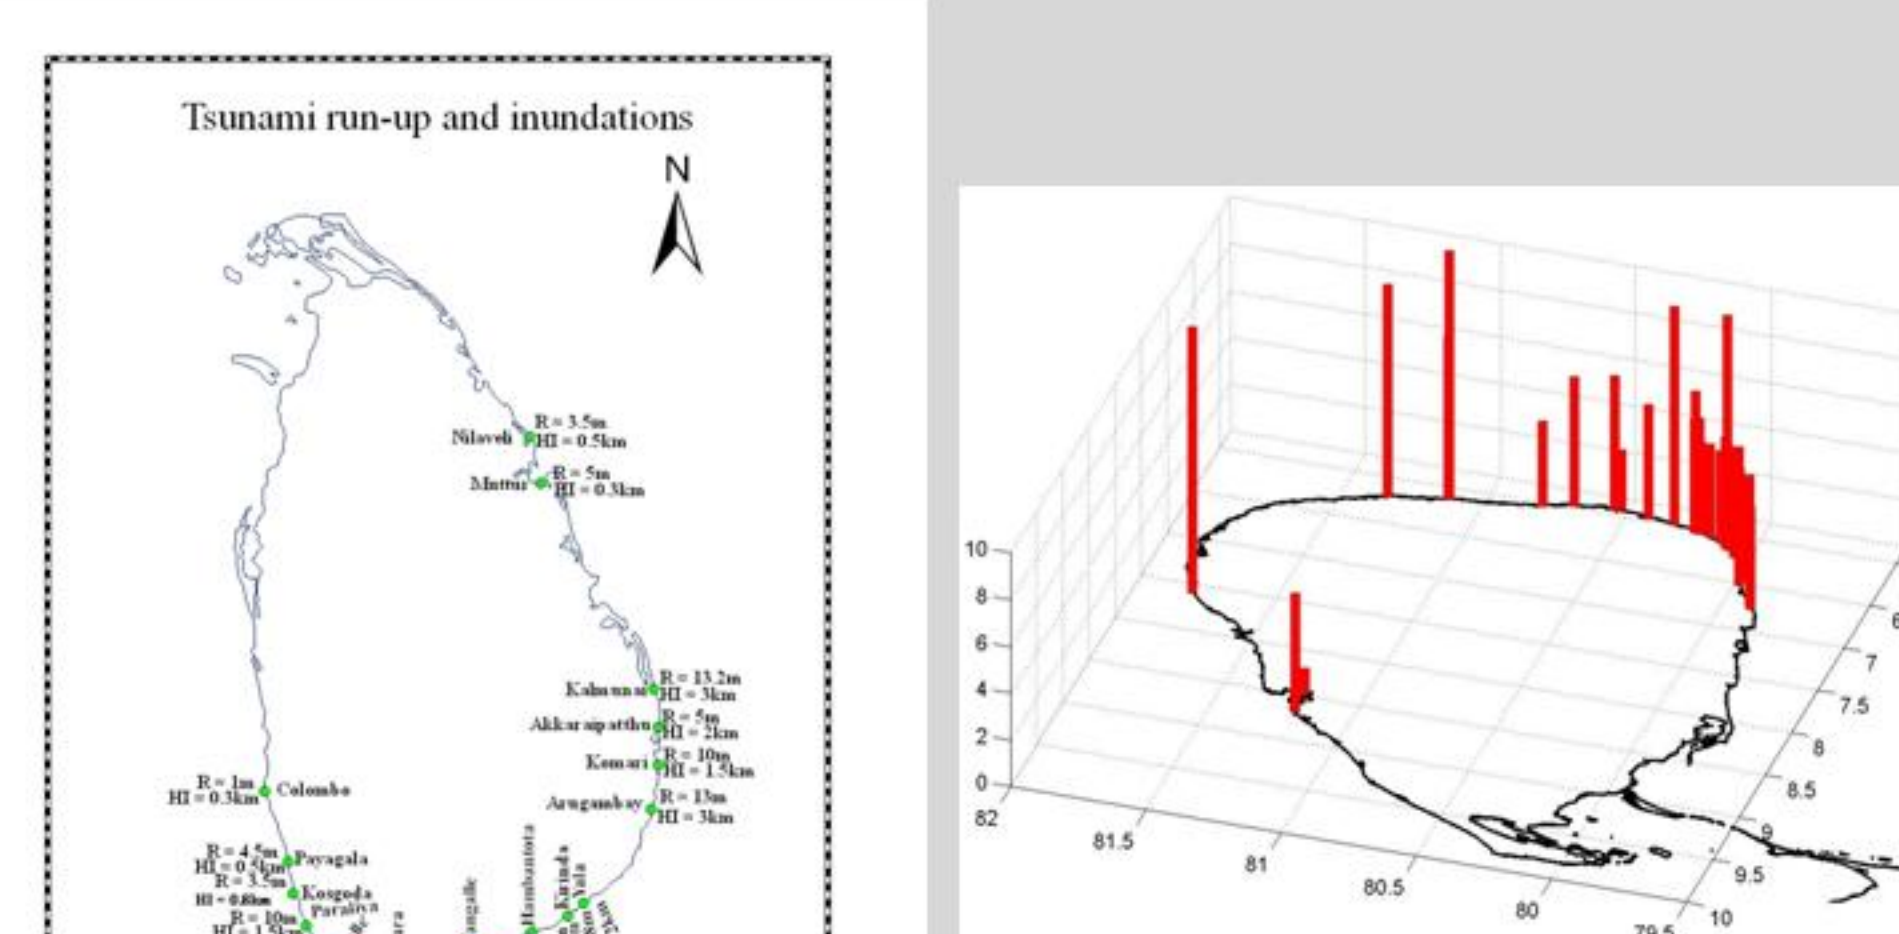
Fig 1. Tsunami run-up and inundation around country

The Fig. 1 shows the run-up and horizontal inundations in selected sites which were the places most severely affected by tsunami. It indicates minimum run-up of 1m at Colombo and maximum of 13.2m at Kalmunai (Fig 2).

Horizontal inundation varies from 0.3 to 3km at respective sites. Also, the study reveals that most of the areas were highly damaged due to widely spread horizontal inundation. However, field investigations indicated that horizontal inundations were below the expected level. The differences may be due to influences of coastal geomorphology and coastal topography of the area

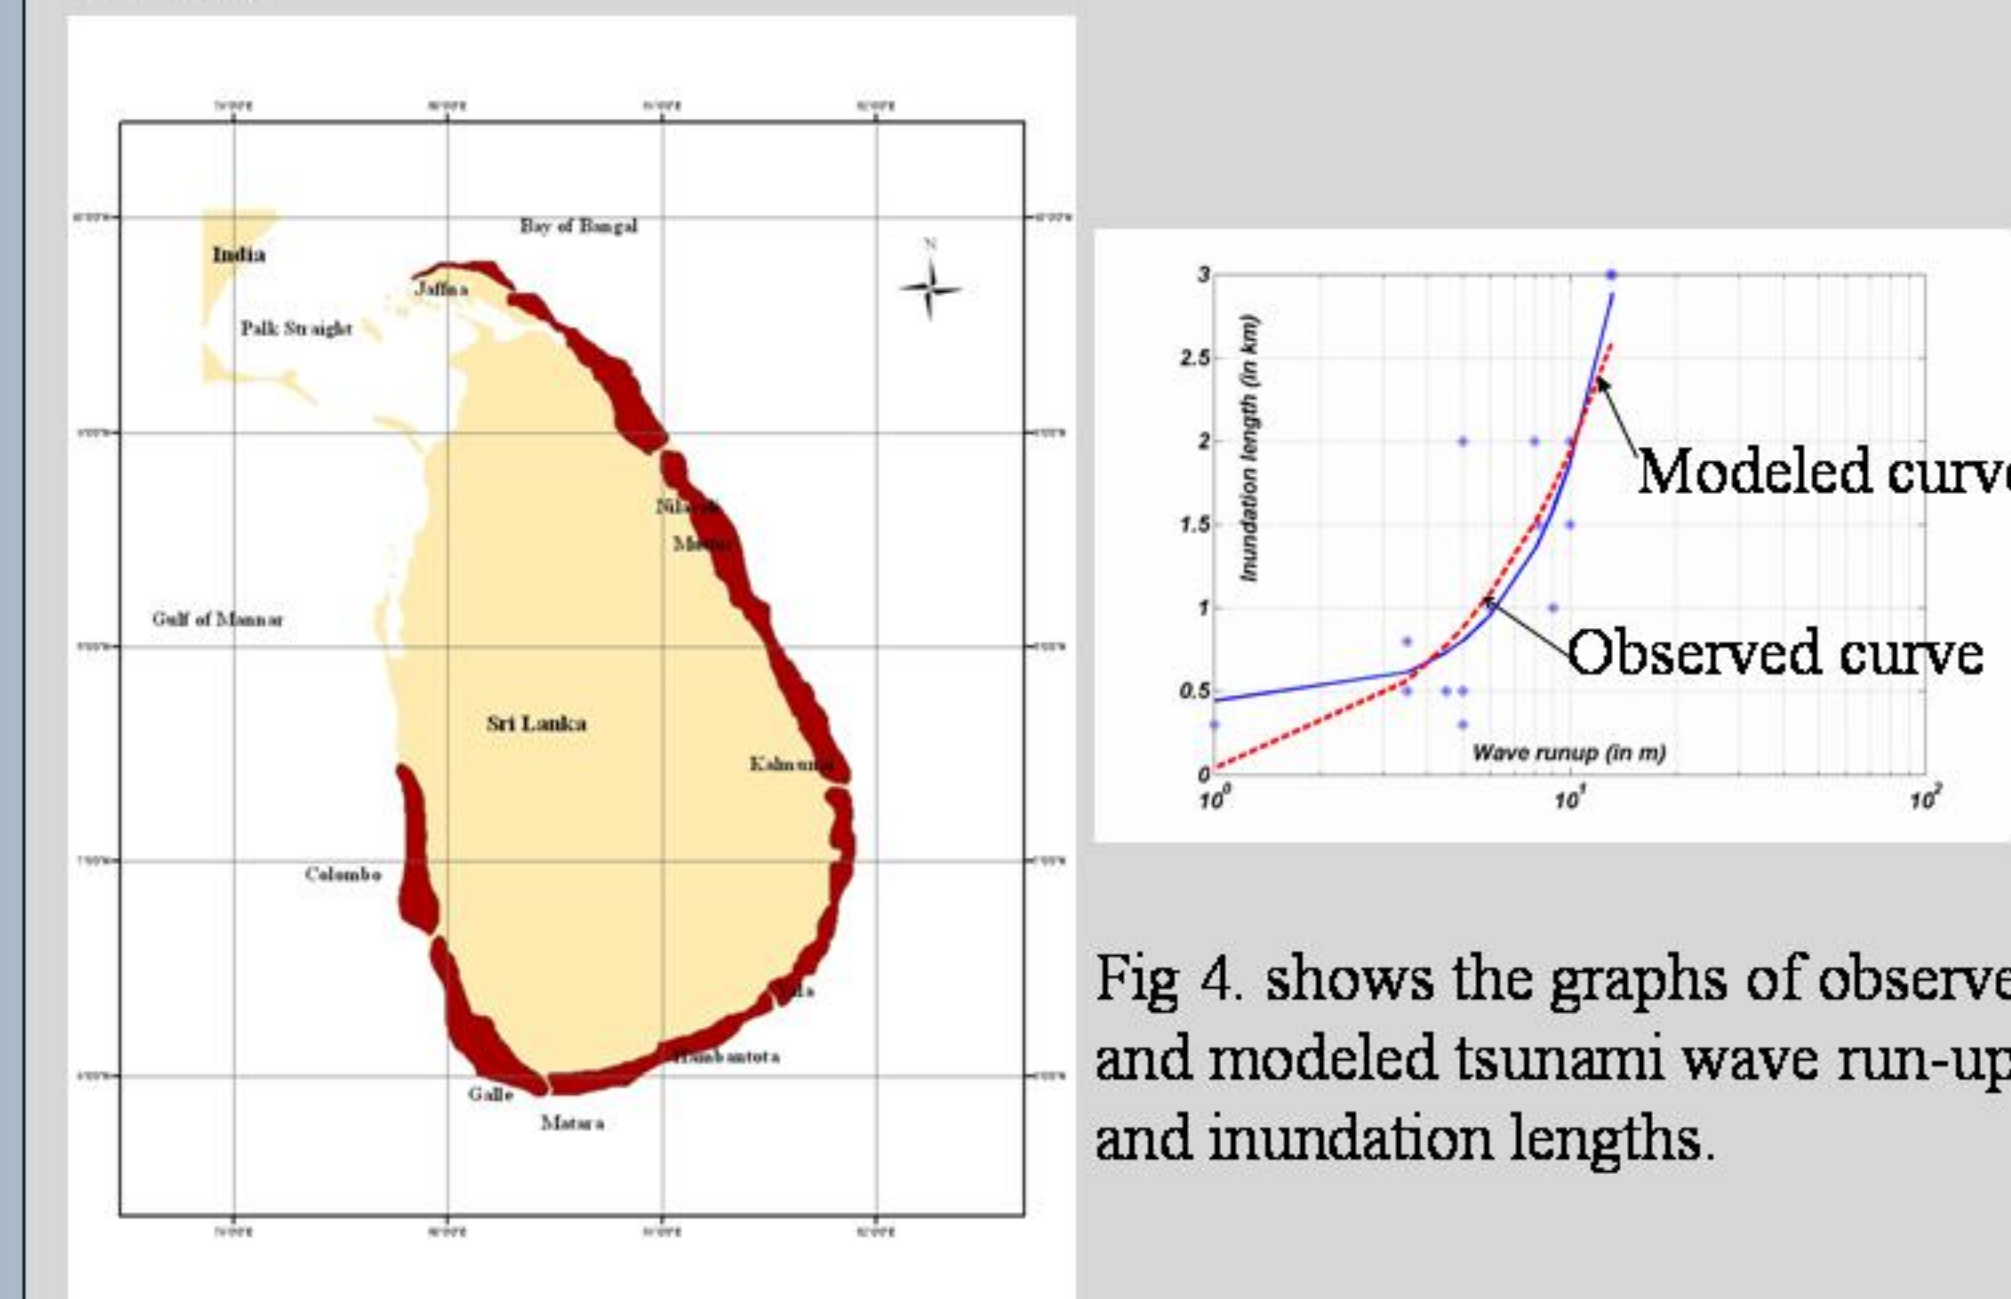
Fig 3. Horizon inundation mapping

The Figure 3 illustrates the tsunami horizontal inundation around Sri Lanka. Inundation lengths are varied from several hundreds of meter to few kilometers. The investigations revealed that coastal morphology directly influenced the flow of tsunami waves through low land up to several kilometers. Also, it reveals that higher elevations act as a barriers to decrease the inundation lengths. Figure 4 illustrates the graph of run-up verses horizontal inundation. The graph indicates that observed run-up and inundations are not always coincident with the model values and most cases lie below the modeled values. As an example, at the run-up 5m; horizontal inundation is 0.5km at Muttur, 2km Akkaraipattu, and 0.5km at Matara. However, the model curve representing the expected inundation is about 0.8km. The field observation indicated similar situations all over the country.

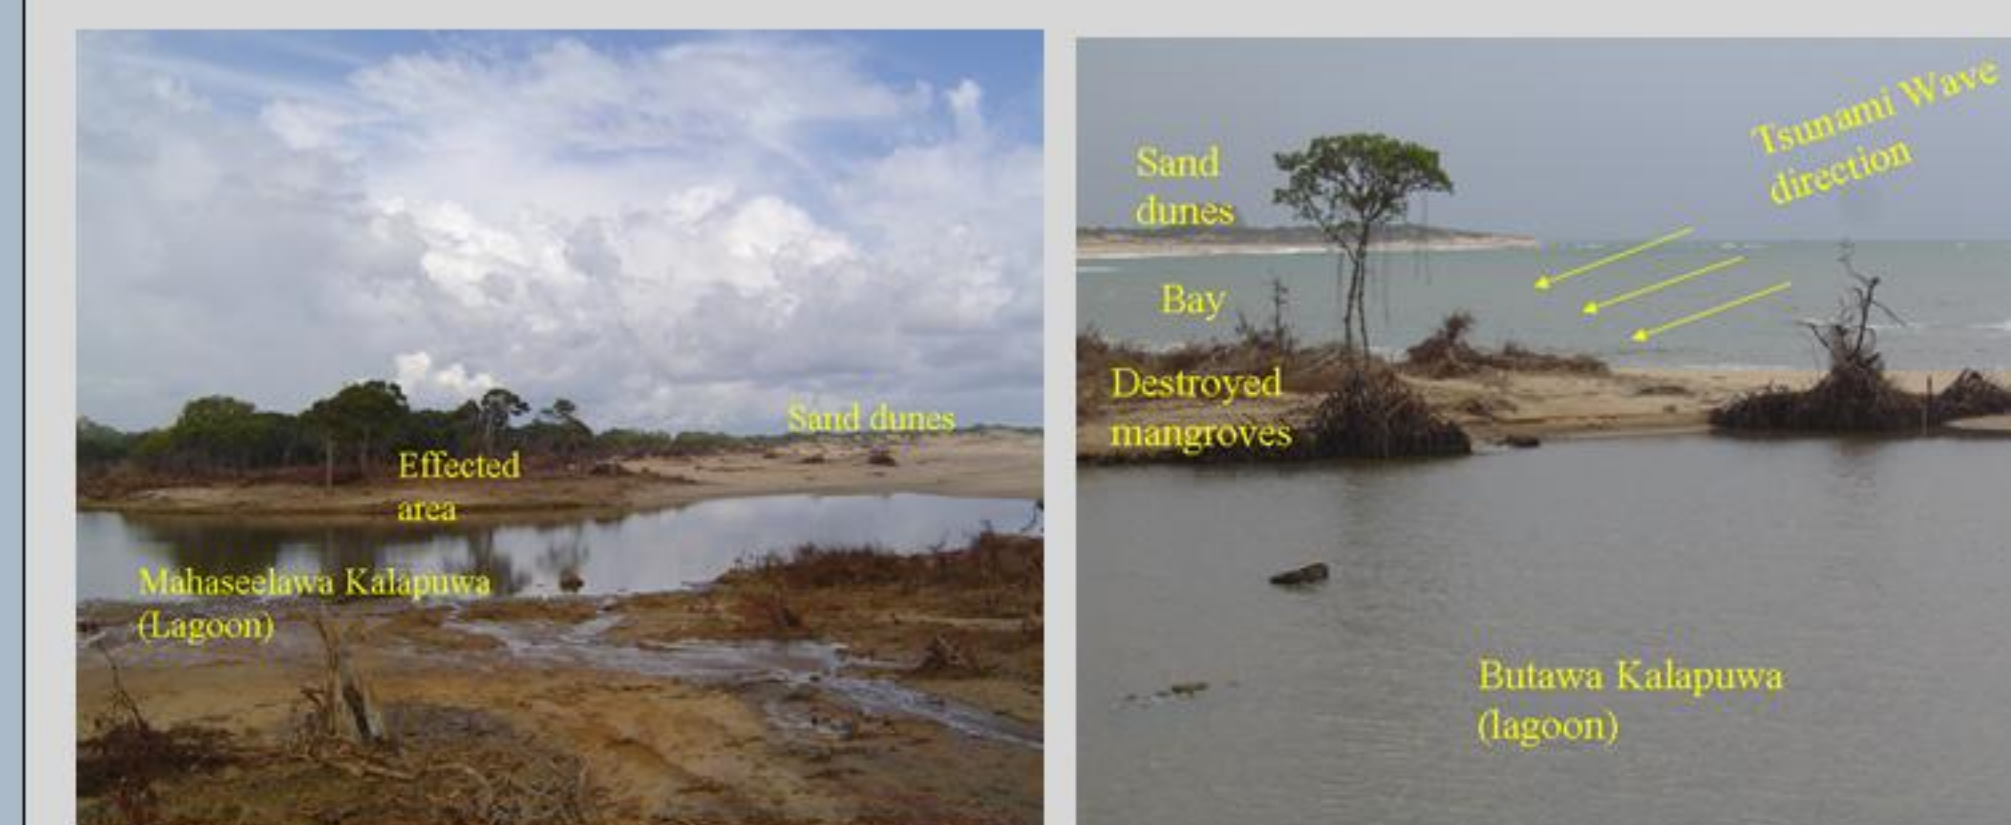
Fig 5. Tsunami affected area at Mahaseelava Kalapuwa (lagoon)

Fig 6. Tsunami affected area at Butawa Kalapuwa

Figure 5 illustrates the post tsunami impacted area of Mahaseelava lagoon in Yala national park. The survey area is covered by natural barriers like sand bars and sand dunes. The mouth of the lagoon is the only low elevated area which was the possible entrance for tsunami wave. Tsunami waves were compacted by the narrow entrance and coastal morphologies which increased the impact of the damages.

Figure 6 shows the tsunami affected area of Butawa Kalapuwa. Tsunami arrival direction is marked by arrows. The adjacent headlands which are formed by sand dunes funneled water to the lagoon. Also, remnants of coastal mangroves destroyed by the Tsunami could be observed in the field. The important fact that could be observed in this area is the increases of wave impact by headland and bay structure.

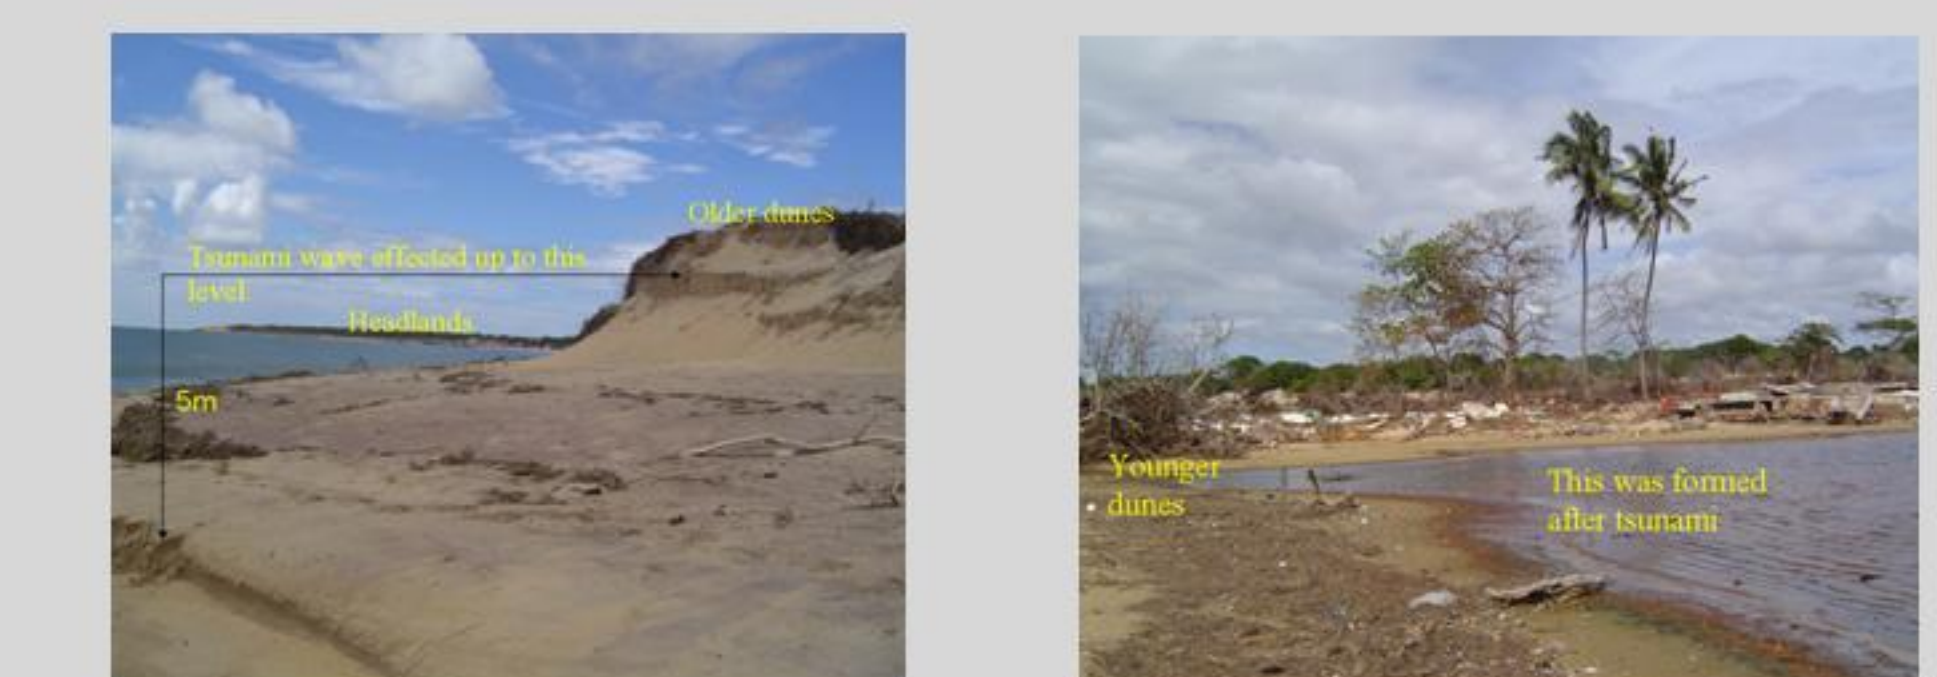
Fig 9 Tsunami run-up at Yala Safari

Fig 10 Tsunami wave entrance through younger dunes

Tsunami wave impact of the Patanangala area is given in Figure 7. The area is represented by a bay where entrance by sand bar influences water coming into the bay. The field observations indicated that the tsunami wave enters through younger dunes to the bay. The area was totally destroyed by the tsunami wave. Figure 8, 9 and 10 show snapshots of tsunami impacted areas in Yala. The area is covered by two adjacent headlands which are formed by sand dunes. Figure 8 indicates the height from low tide terrace to berm crest. Figure 9 shows the height from beach to maximum height to crest of the tsunami wave. Figure 10 illustrates the area of newly formed younger dunes. Also, it shows Brown beach hotel which was the totally destroyed by tsunami wave entered over the younger dunes.
